Ultra-slim hybrid staircase pushes the boundaries of glass and concrete

The recent renovation of the ABT headquarters in Velp, The Netherlands afforded the building a contemporary look. A true eye-catcher is the staircase in the lobby, which has been designed and constructed with the aid of the latest technology. The result is a unique piece of work, with an astonishing slenderness and multiple structural innovations.

Ultra-slim hybrid staircase, Velp, The Netherlands

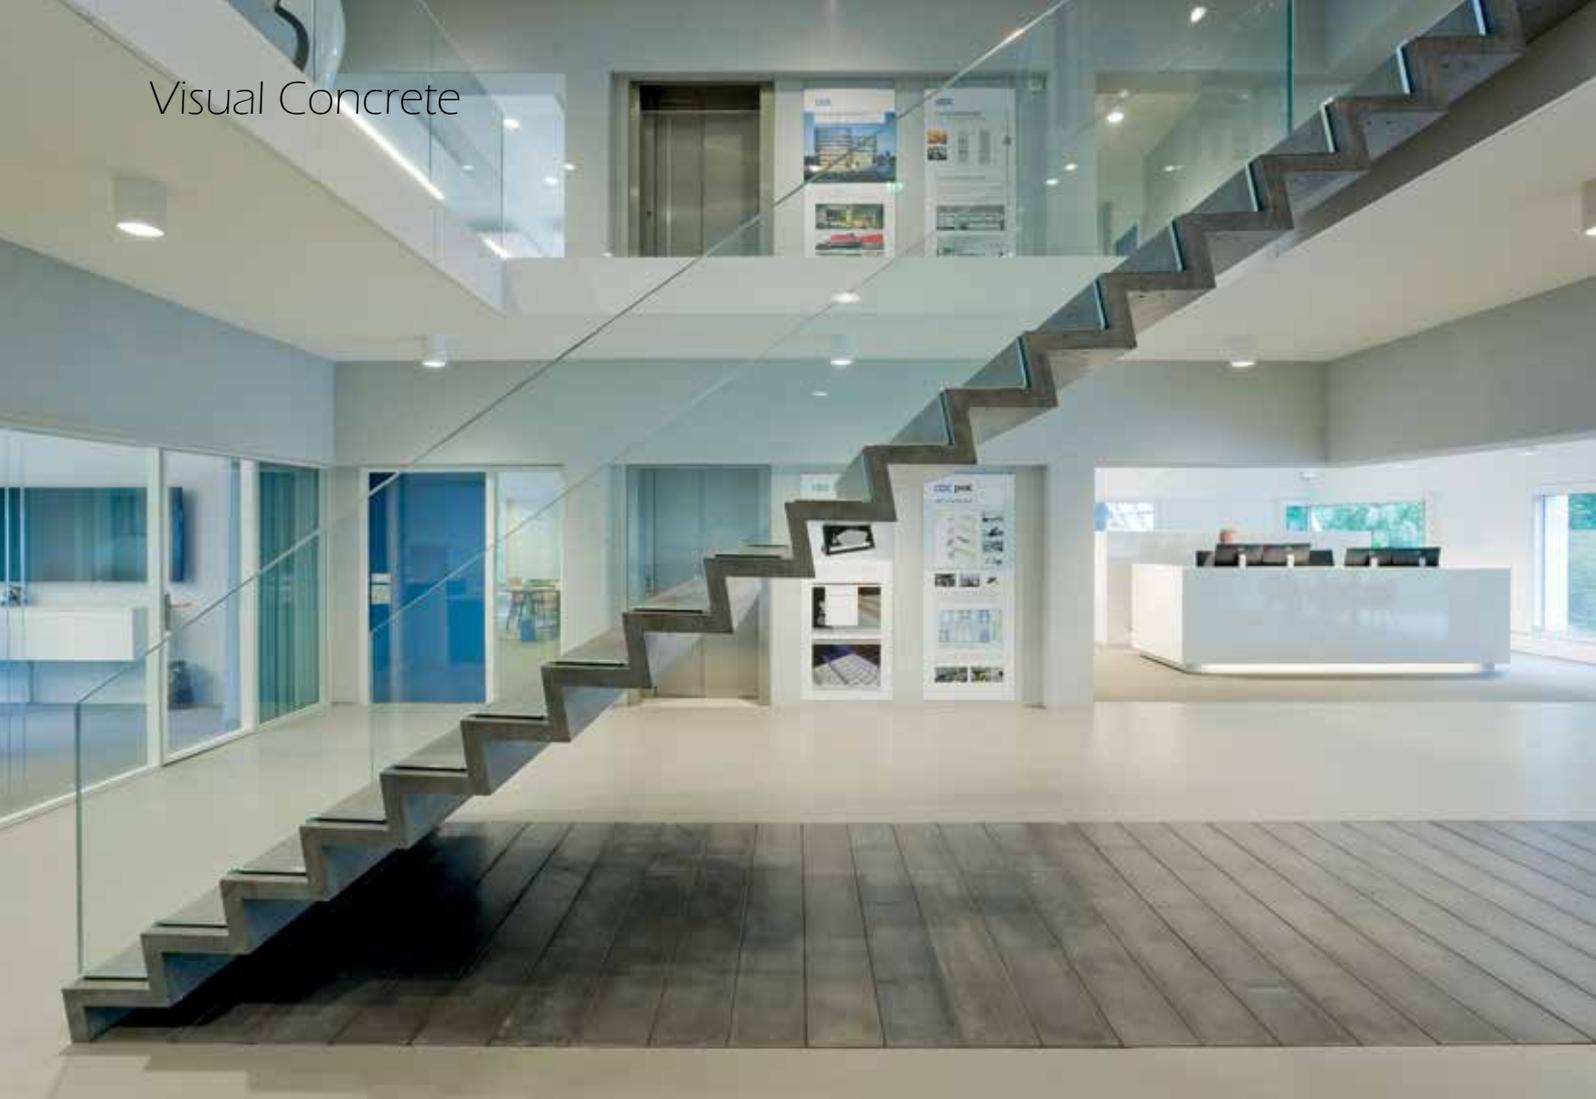
The concrete staircase was made with prefabricated concrete. To get the staircase in situ, a special frame was developed to facilitate the transport and the positioning. During its positioning, the staircase was structurally anchored into the building. A special load was placed on the staircase, through which it underwent a part of the material creep. This process was monitored very closely. Following the preloading, the staircase was

measured and the glass was manufactured according to the measurements. The glass was connected to the concrete. The connection is unique of its kind and had to be developed specifically for this application, consisting of a steel strip glued to the glass edges and bolted to the concrete. After installation of the glass handgrip, the structure could be used.
